# Manhole Inspection Summary

Manhole # S41E2\_001MH

Insp Date: **3/28/08 1:45 PM**

**Location** Address: **911 Honaker Ct.**

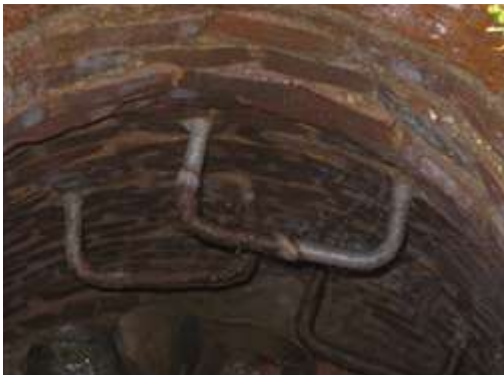
**Steps** Count: **3** Missing: **0** ☒ **Corroded**

steps

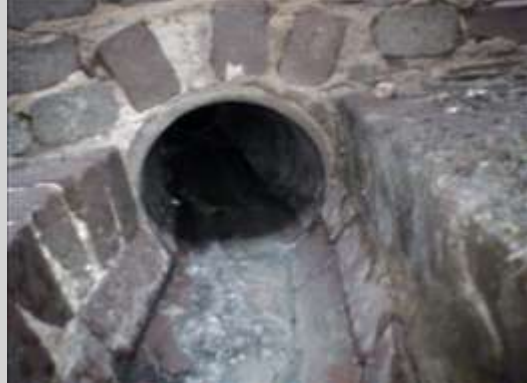
12 O'Clock Outflow

10 in. Circular Gravity Sewer  
Pipe Out @ 12 O'Clock

Pipe Height: **9.6** (in.) Rod and Bar (Angled)  
Pipe Material: **Clay** ☐ Pipe Lined  
Invert Depth: **8.04** (ft.) Flow Characteristics: **Slow**  
Deposits: ☒ None ☐ Mud ☐ Sludge ☐ Debris ☐ Grease  
Silt Depth: (in.) Deposits Extent:  
Infiltration: **None** Pipe Seal Cond: **Sound**

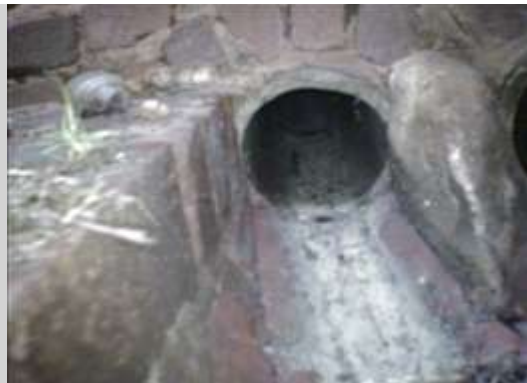
3 O'Clock Inflow

10 in. Circular Gravity Sewer  
Pipe In @ 3 O'Clock

Pipe Height: **9.6** (in.) Rod and Bar (Angled)  
Pipe Material: **Clay** ☐ Pipe Lined  
Invert Depth: **7.44** (ft.) Flow Characteristics: **Slow**  
Deposits: ☒ None ☐ Mud ☐ Sludge ☐ Debris ☐ Grease  
Silt Depth: (in.) Deposits Extent:  
Infiltration: **None** Pipe Seal Cond: **Sound**

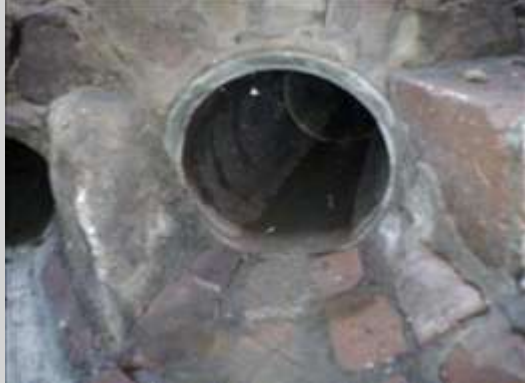
6 O'Clock Inflow

6 in. Circular Gravity Sewer

Pipe In @ 6 O'Clock

Infiltration: **None**

Pipe Seal Cond: **Sound**

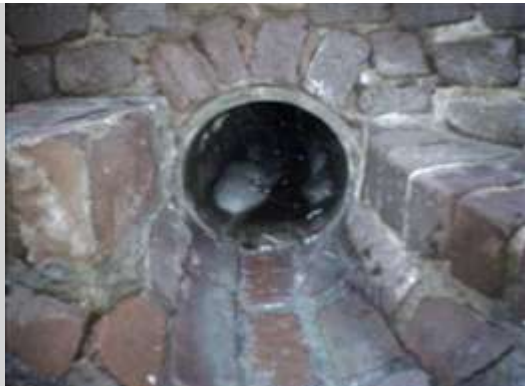
7 O'Clock Inflow

10 in. Circular Gravity Sewer

Pipe In @ 7 O'Clock

Infiltration: **None**

Pipe Seal Cond: **Sound**

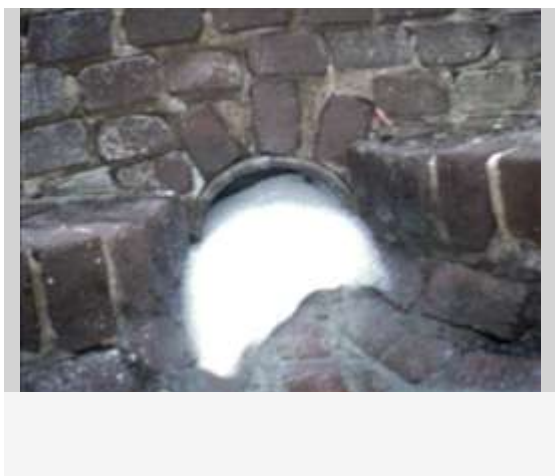
9 O'Clock Inflow

8 in. Circular Gravity Sewer  
Pipe In @ 9 O'Clock

Pipe Height: **8.4** (in.) Rod and Bar (Angled)  
Pipe Material: **Clay** ☐ Pipe Lined  
Invert Depth: **7.50** (ft.) Flow Characteristics: **Slow**  
Deposits: ☒ None ☐ Mud ☐ Sludge ☐ Debris ☐ Grease  
Silt Depth: (in.) Deposits Extent:  
Infiltration: **None** Pipe Seal Cond: **Sound**
